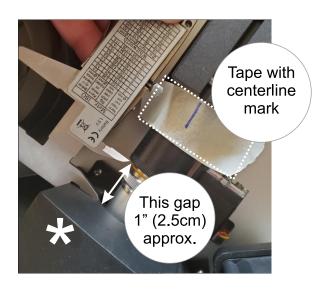
Unless the microscope tube is completely loose in its bracket, put a piece of tape with a centerline mark at the place where the tube meets the bracket. This will serve as a reference during adjustment.

Note that the gap between the tube and the *core cover is approximately 1" (2.5cm).
